# grounds newsletter

We are about halfway through the 2023 golf season. I hope everyone has been enjoying the summer and hitting it straight! Mother Nature has taken us from one extreme to the other in terms of precipitation. Between April 5 - June 24 we were approximately 7.75" of rain below average. There had been 2.25" of rain, within that timeframe. From June 24 - July 17 we have received 7.1". Based on those totals, if I had to bet, I'd say we are going to have another period of dry weather sometime in the near future.

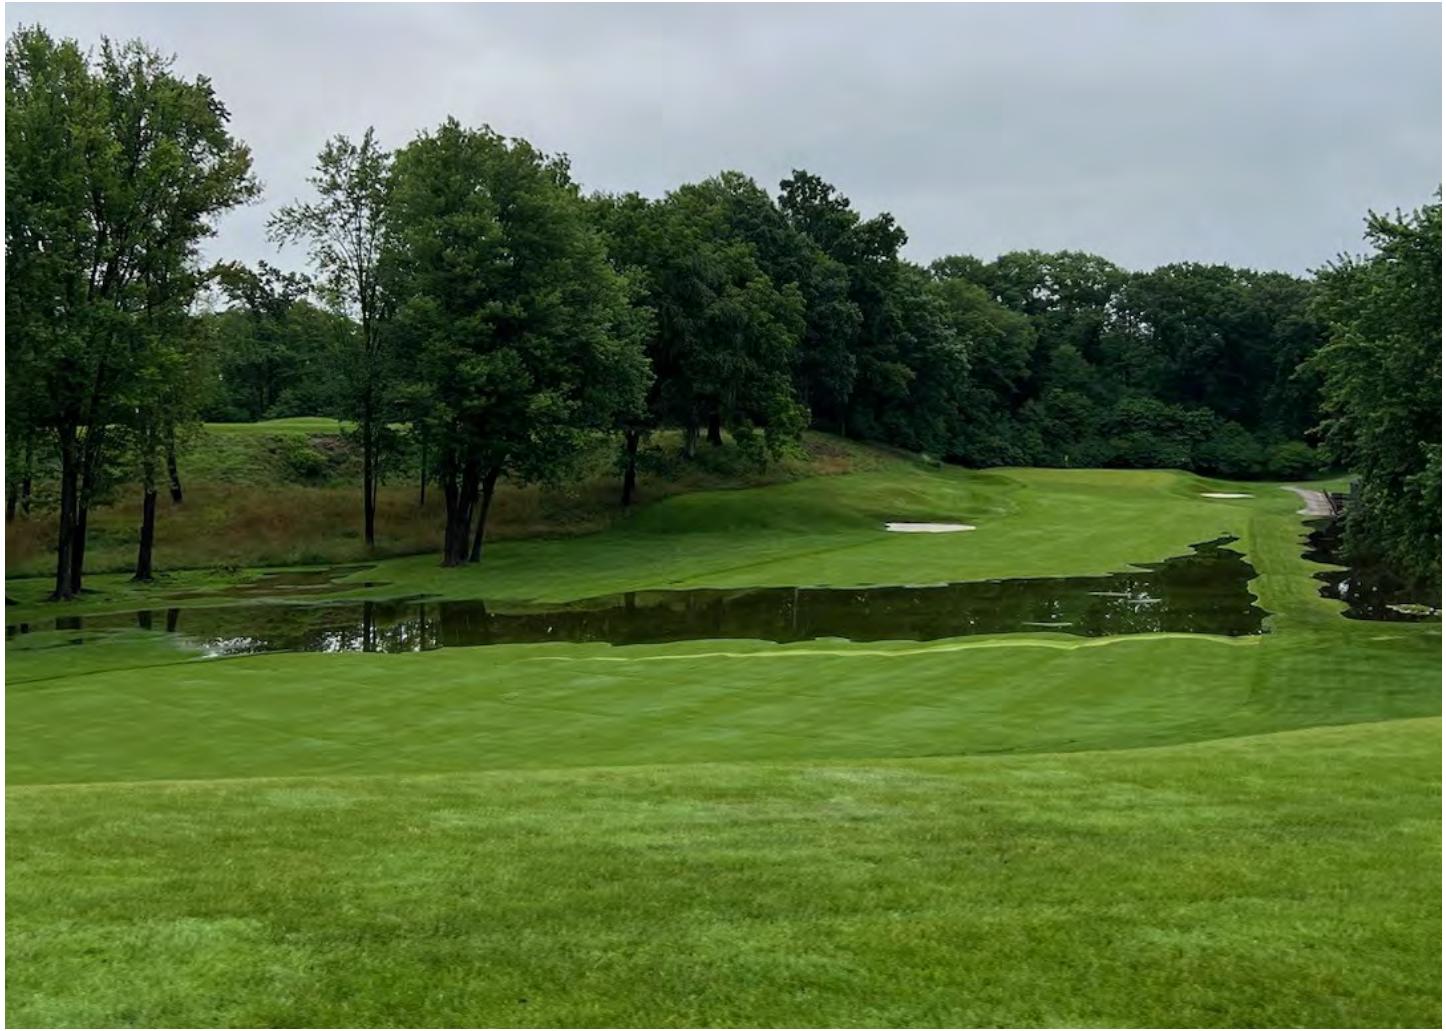
Water covering #5 fairway (Thursday July 13). This is almost the worse I've ever seen #5 in terms of water crossing the fairway. The worst being during the MI Amateur in 2021. The amount of water is due to how fast the water can exit the property and not due to drainage on #5 fairway itself.

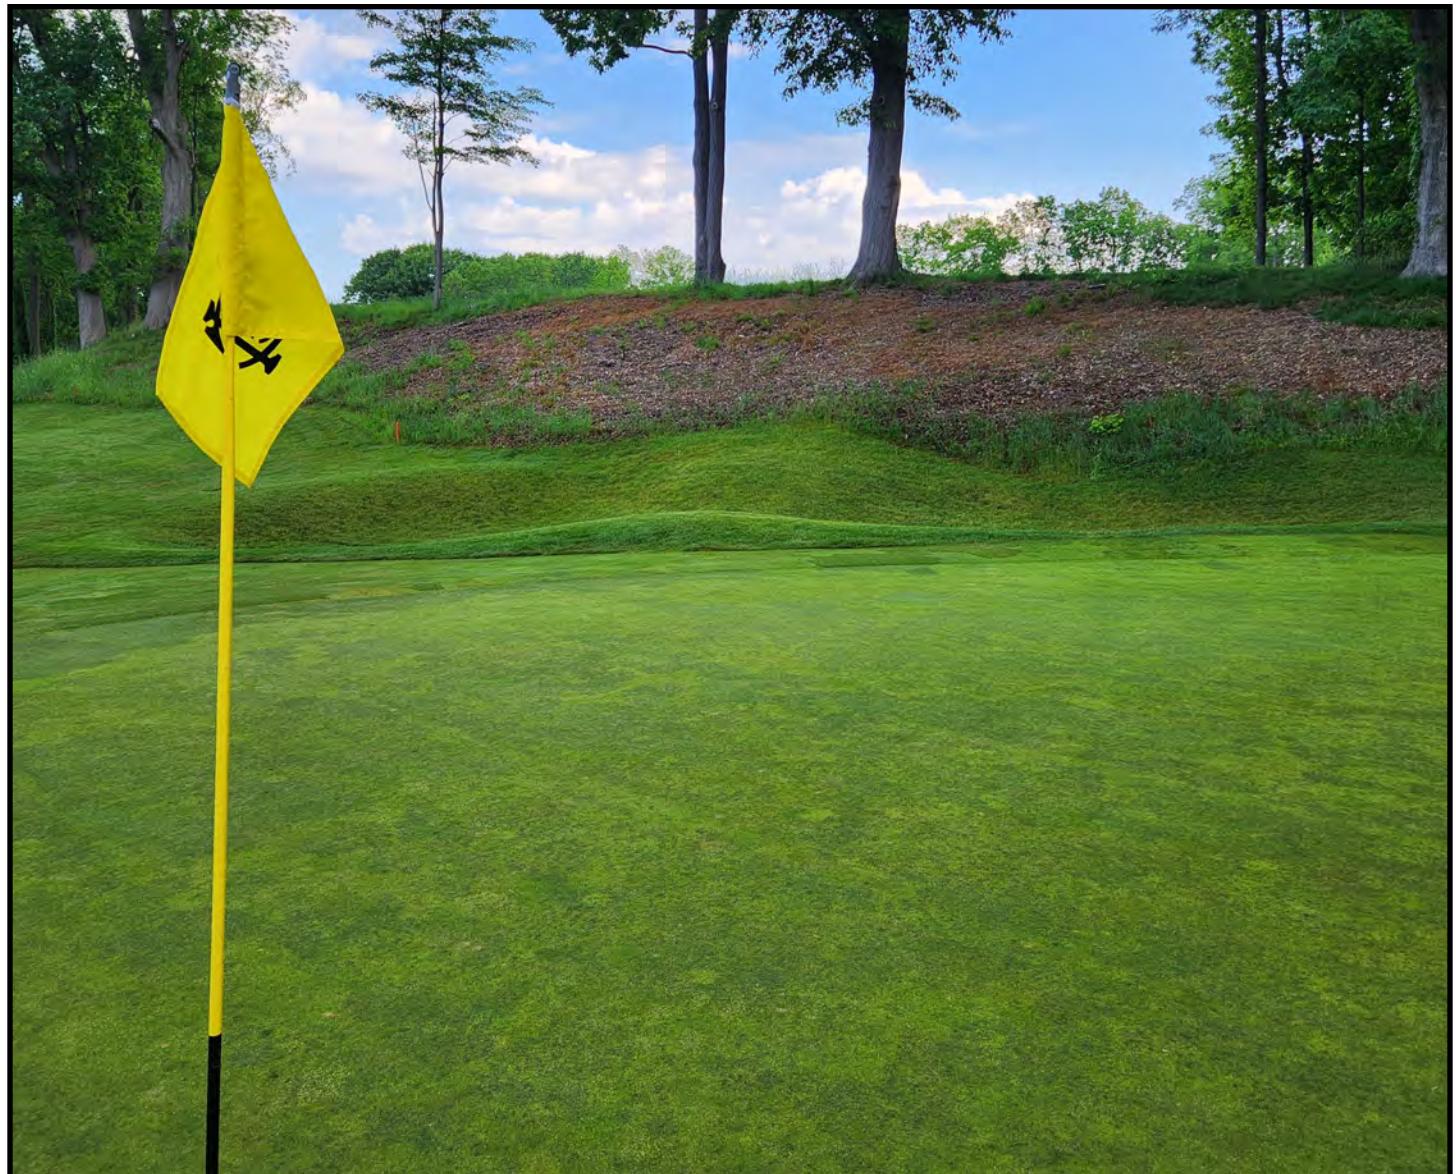
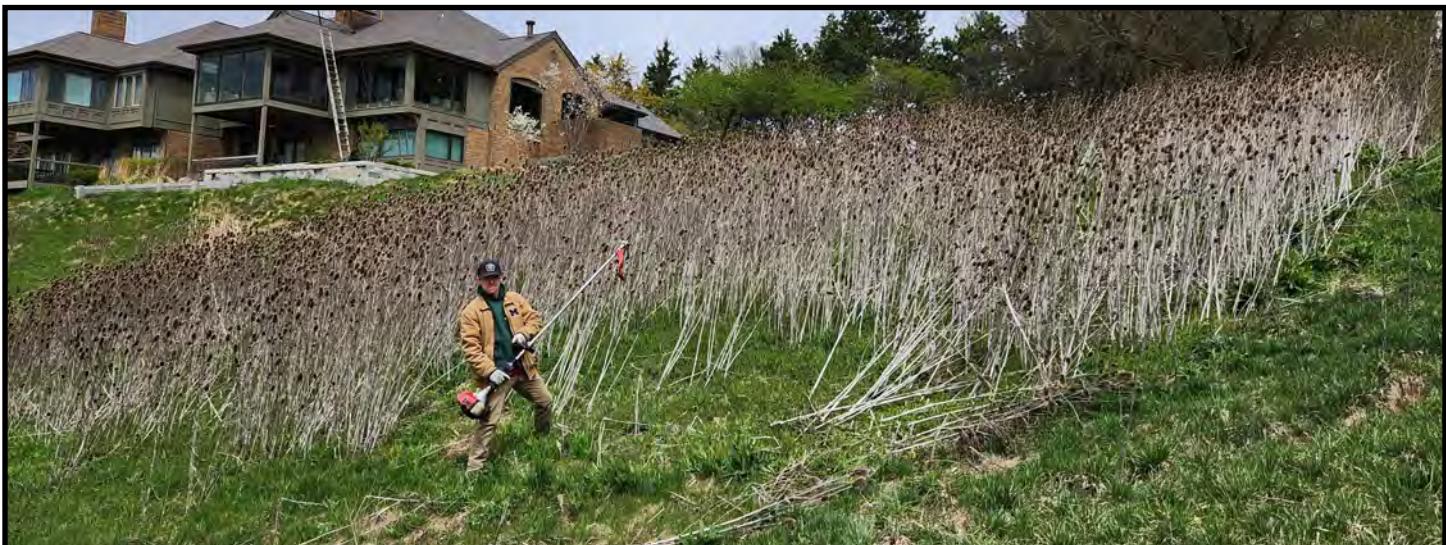
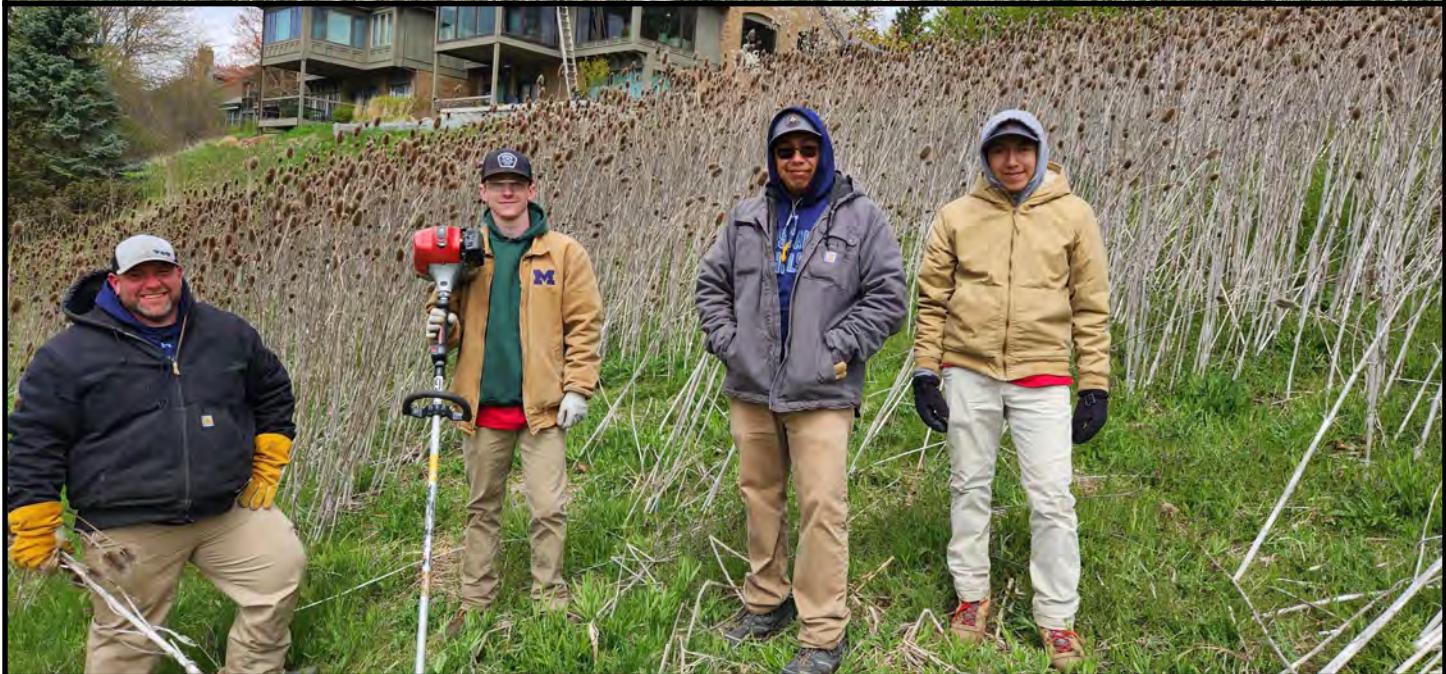
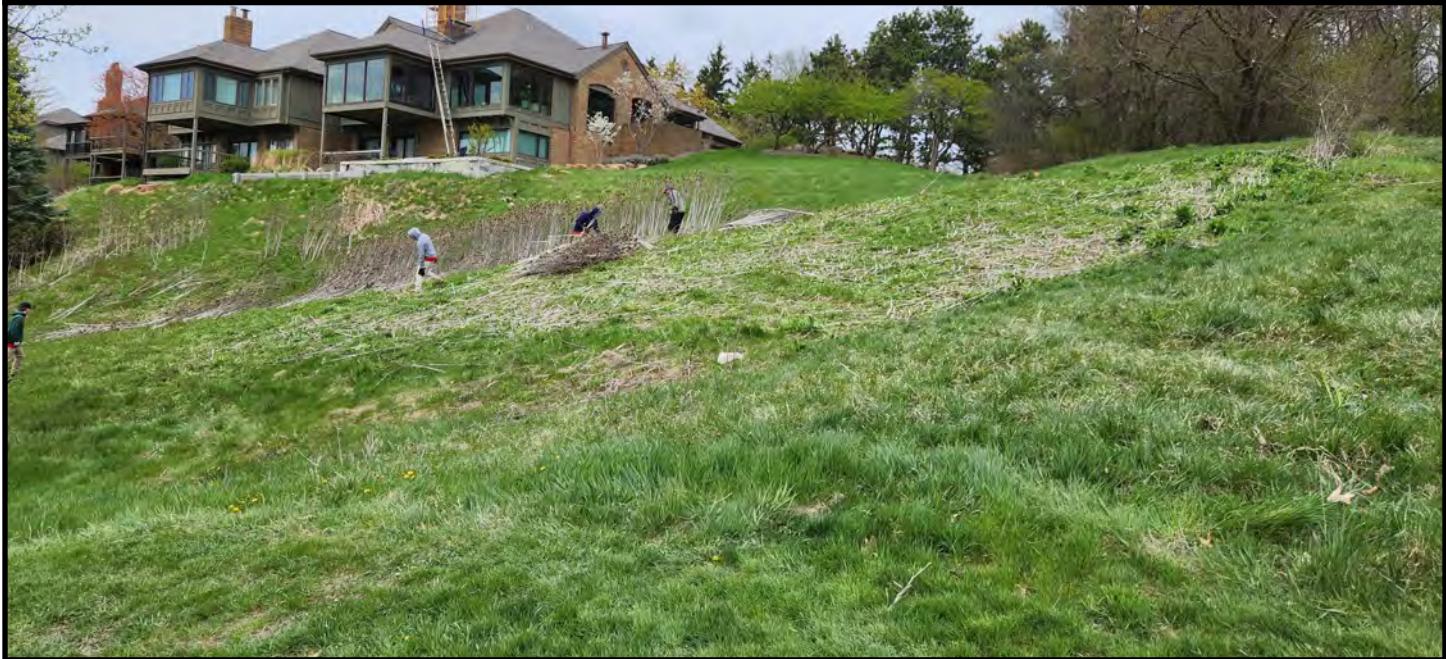
One of our main objectives this year is to eradicate weeds and briar bushes from our unmown native areas. Part of the eradication process involves manually removing material and the other part is controlled through use of selective herbicides.

You will notice certain areas in the native throughout the season that are bare soil, such as left of 5 green. This is an intentional part of the process. We will seed these areas to grass in the fall. I anticipate this process taking a couple of seasons before the grass is fully established.

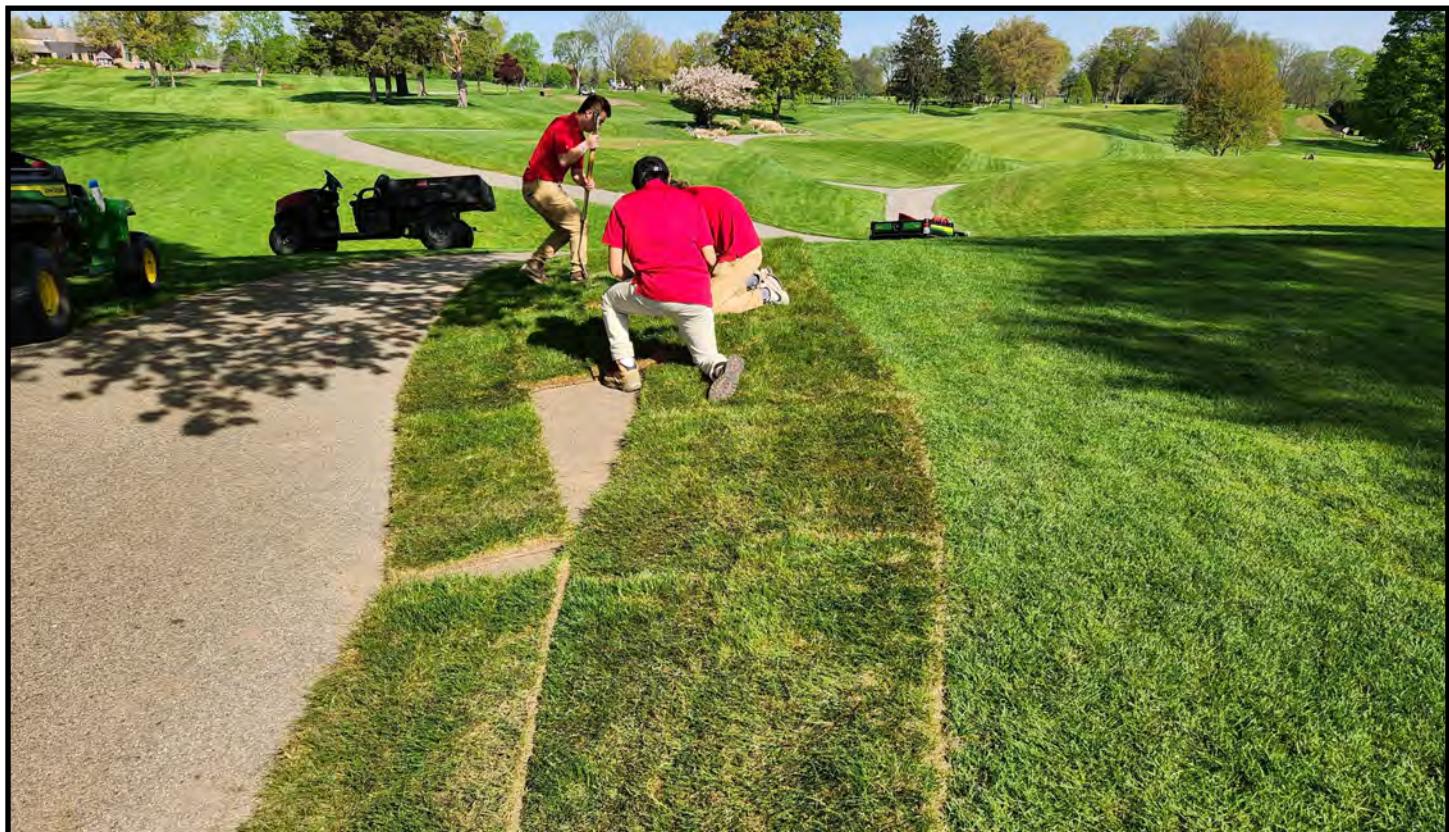
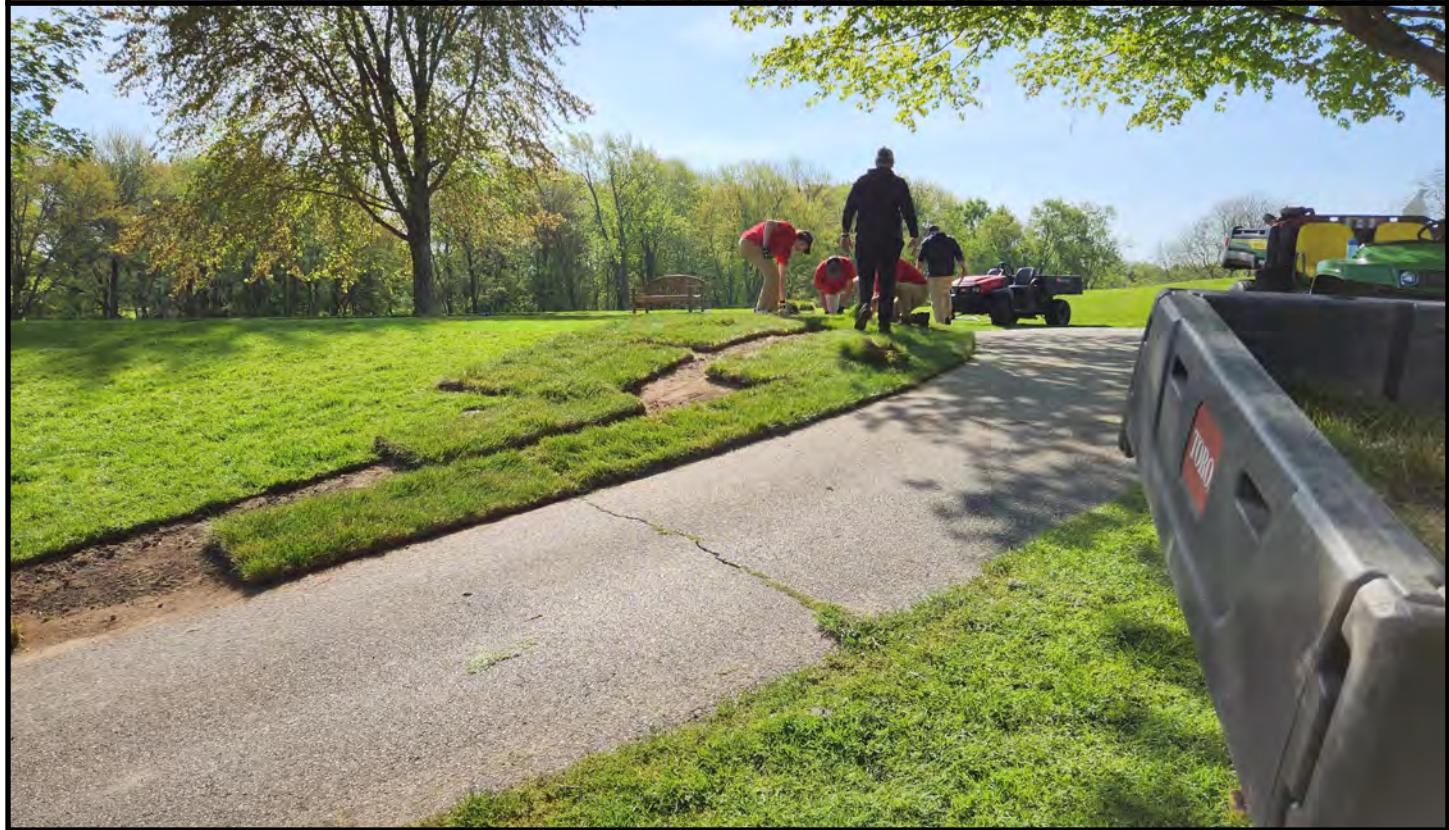
### Cart Path Edges

Sodding the right side of #2 tee.

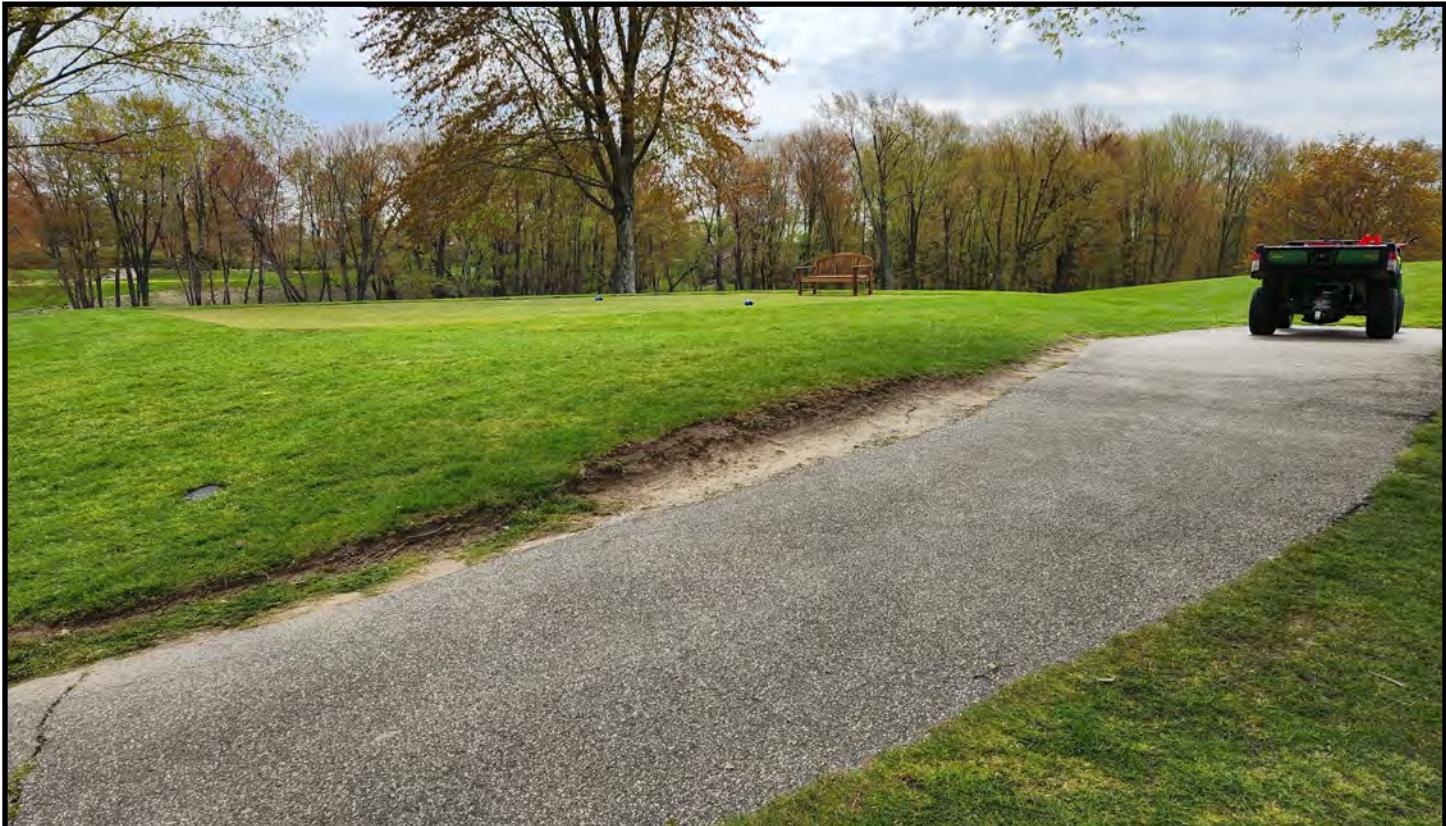
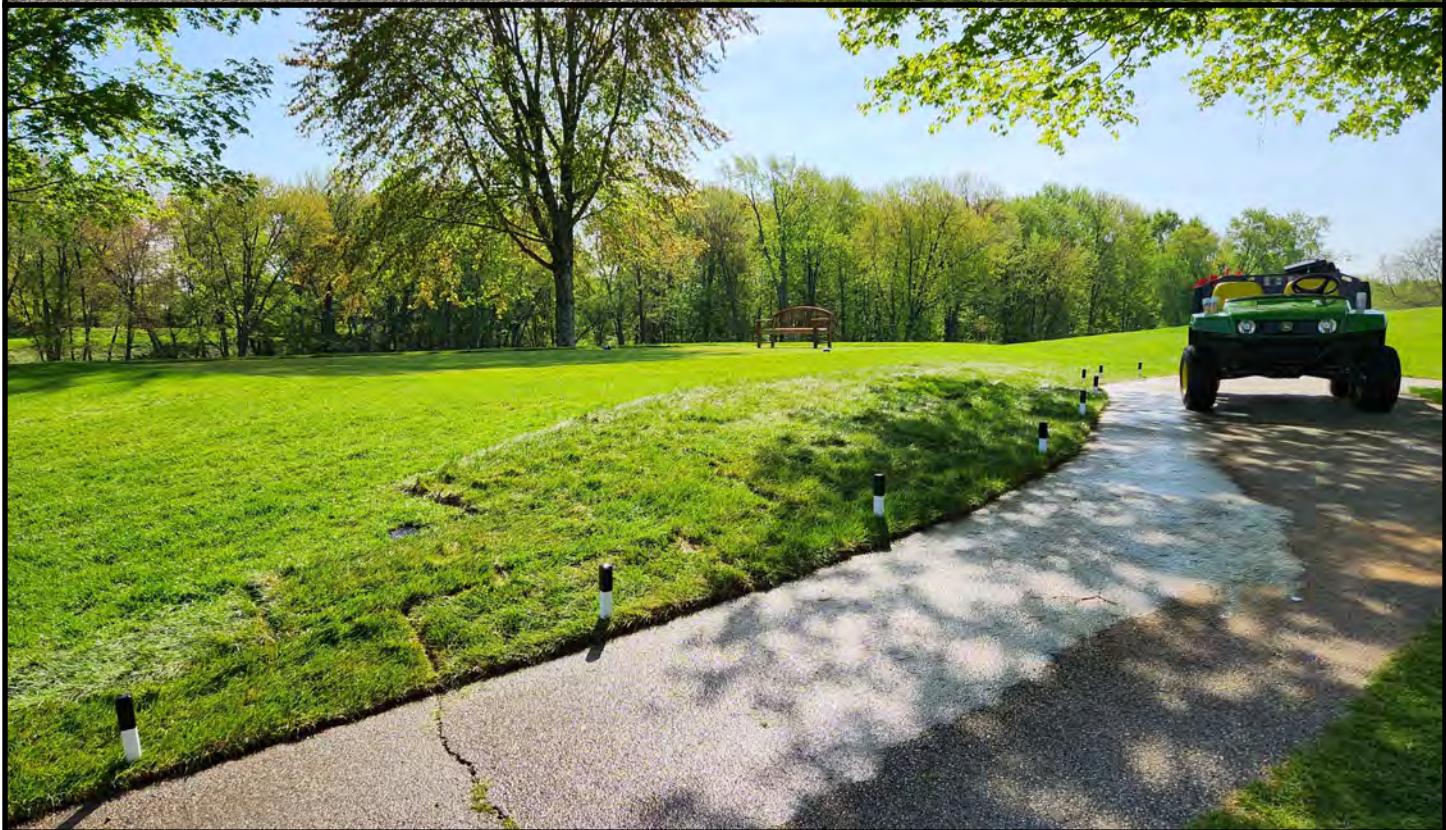
#2 tee before and after

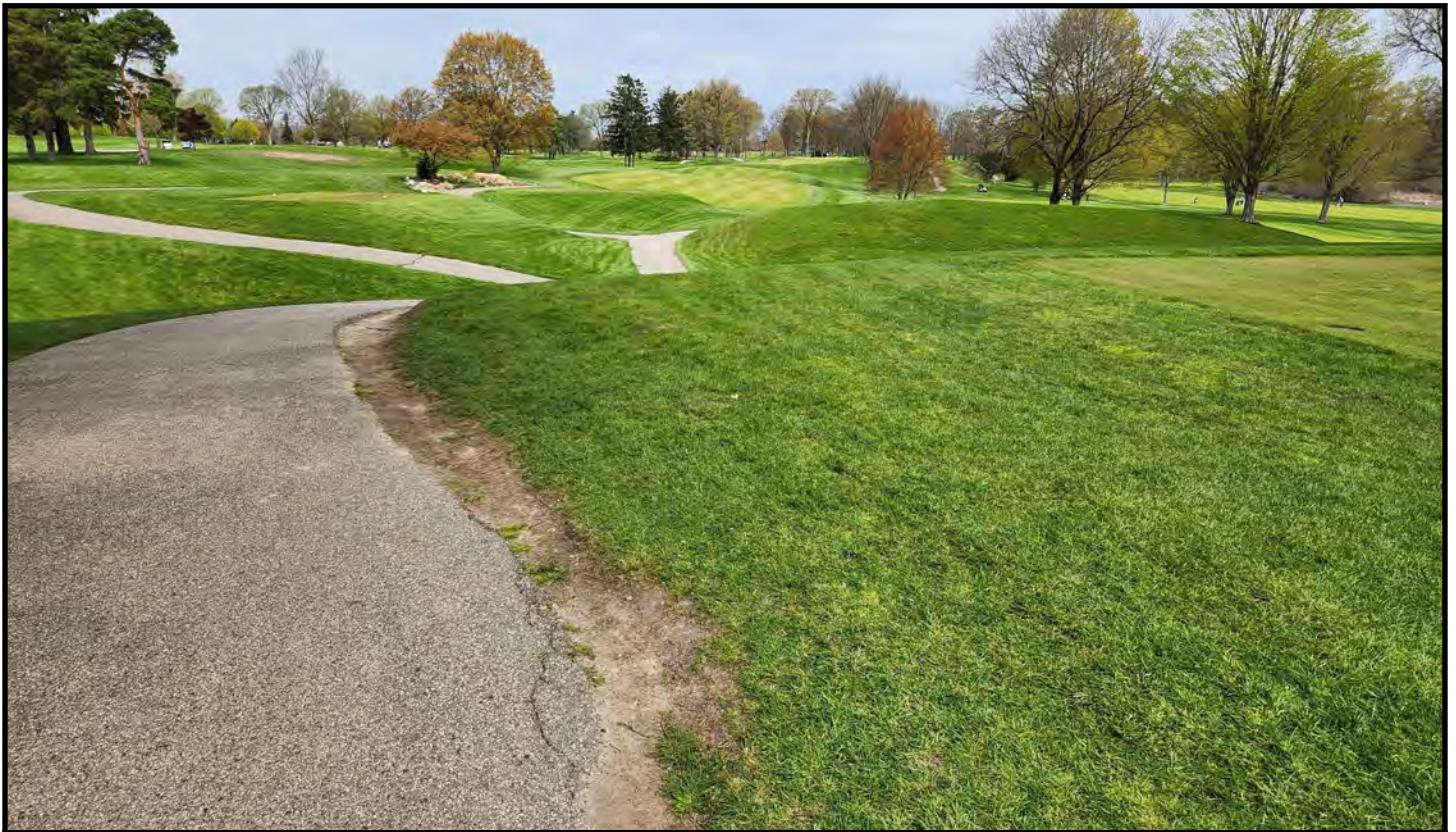
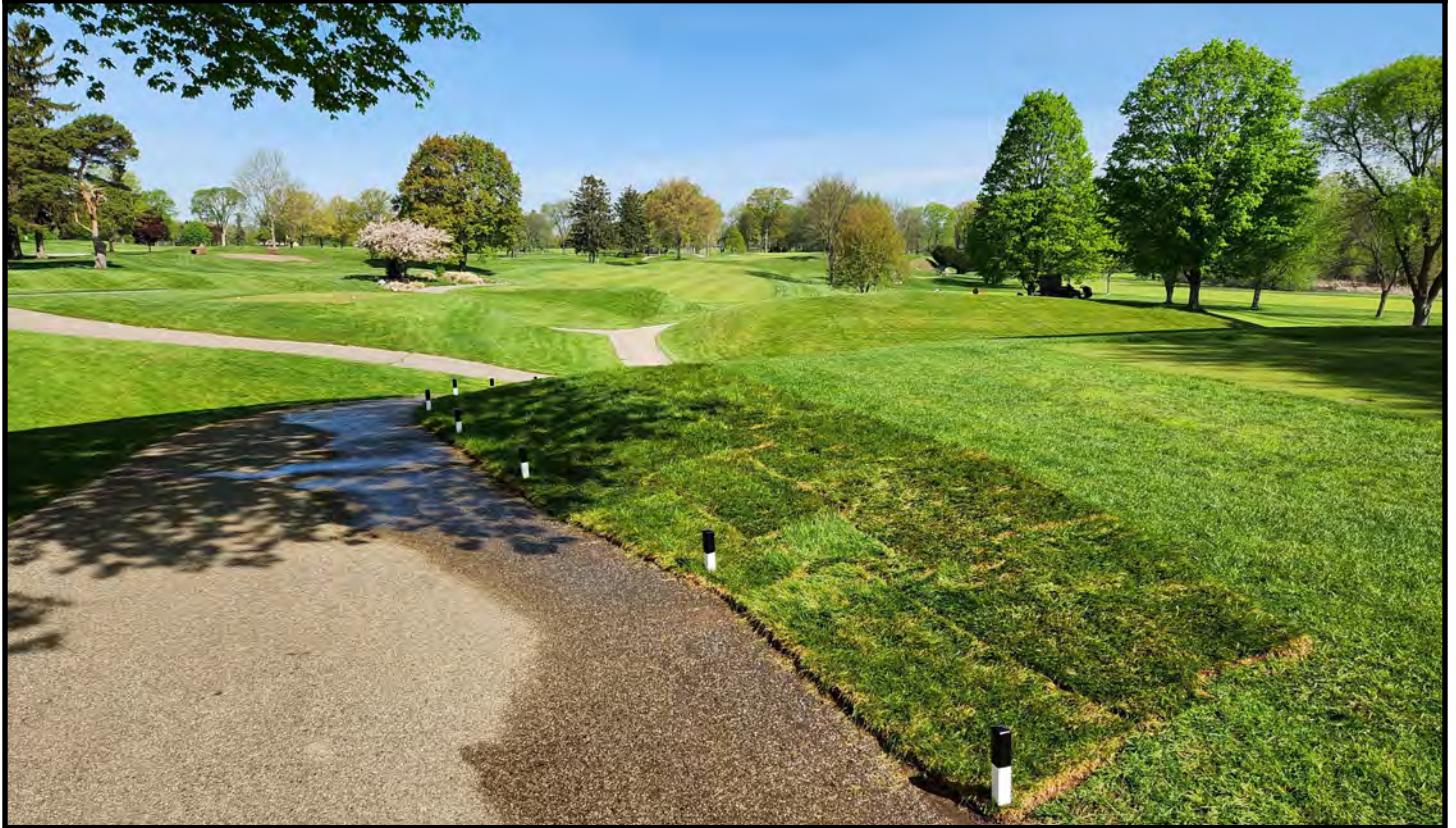
#2 tee before and after

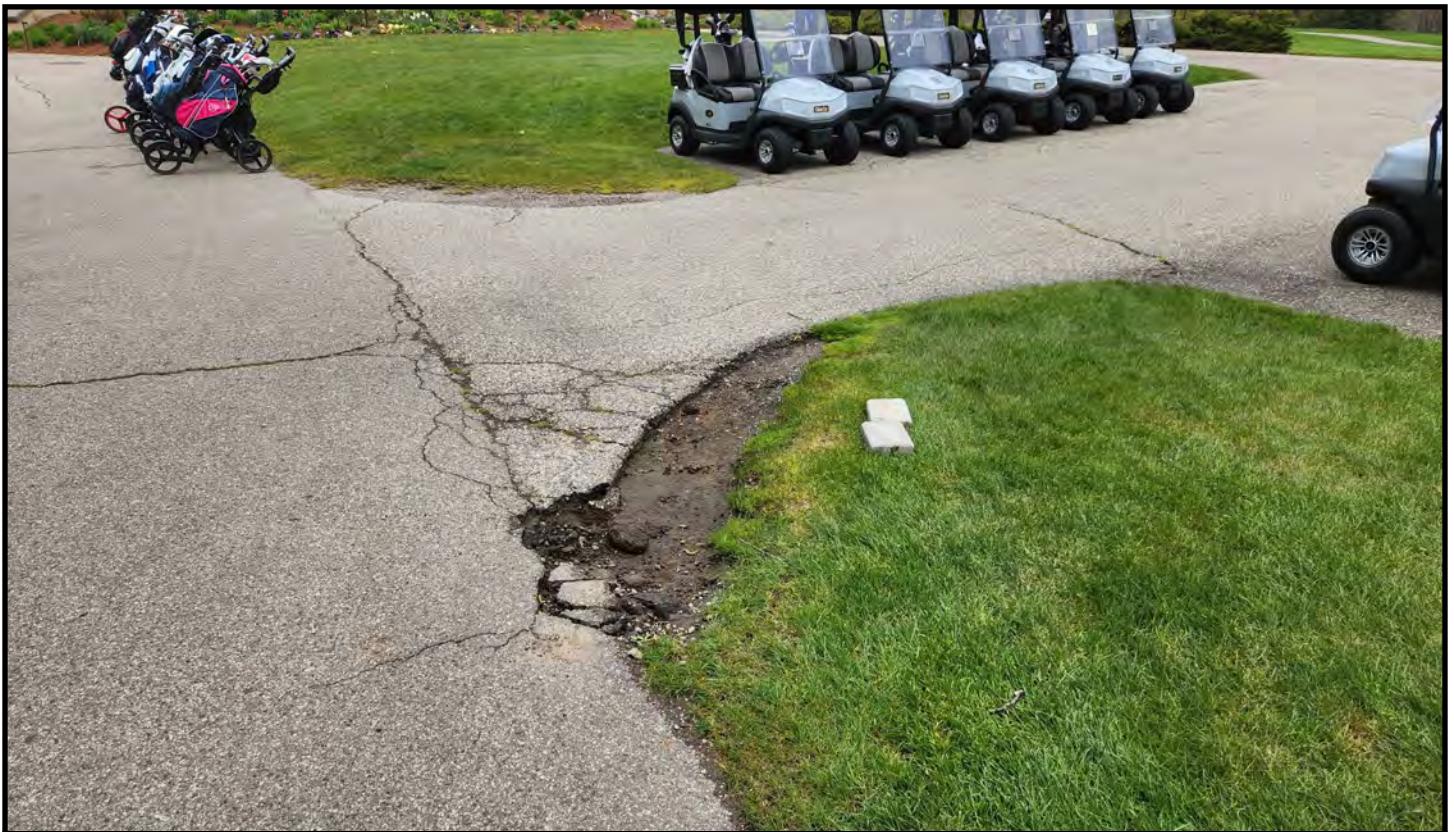
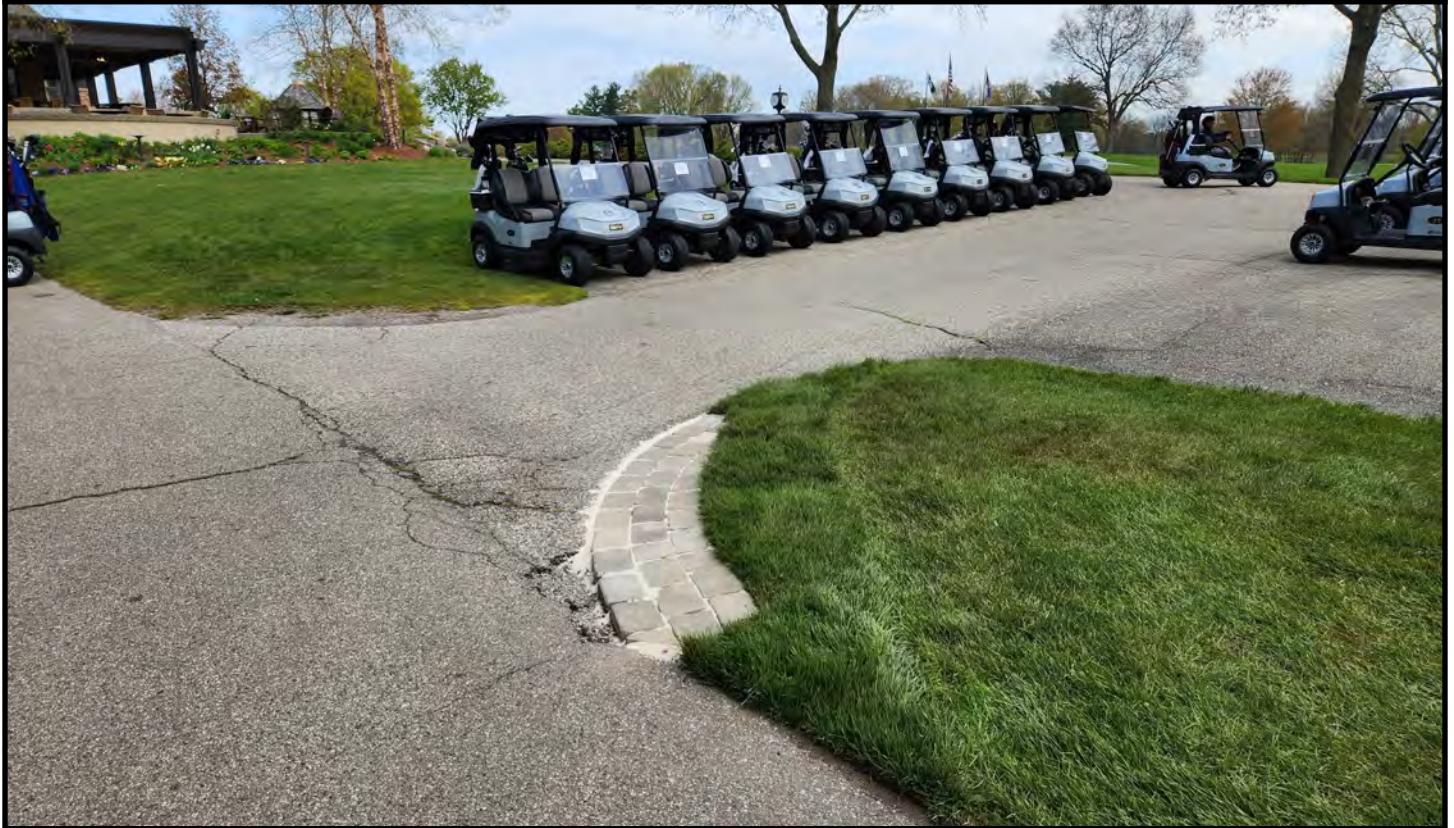
We installed pavers at the corners of the cart staging area as a long term solution to the grass continually dying from a heavy cart traffic area. The pavers previously made up the patio where the tent is now located on concrete.

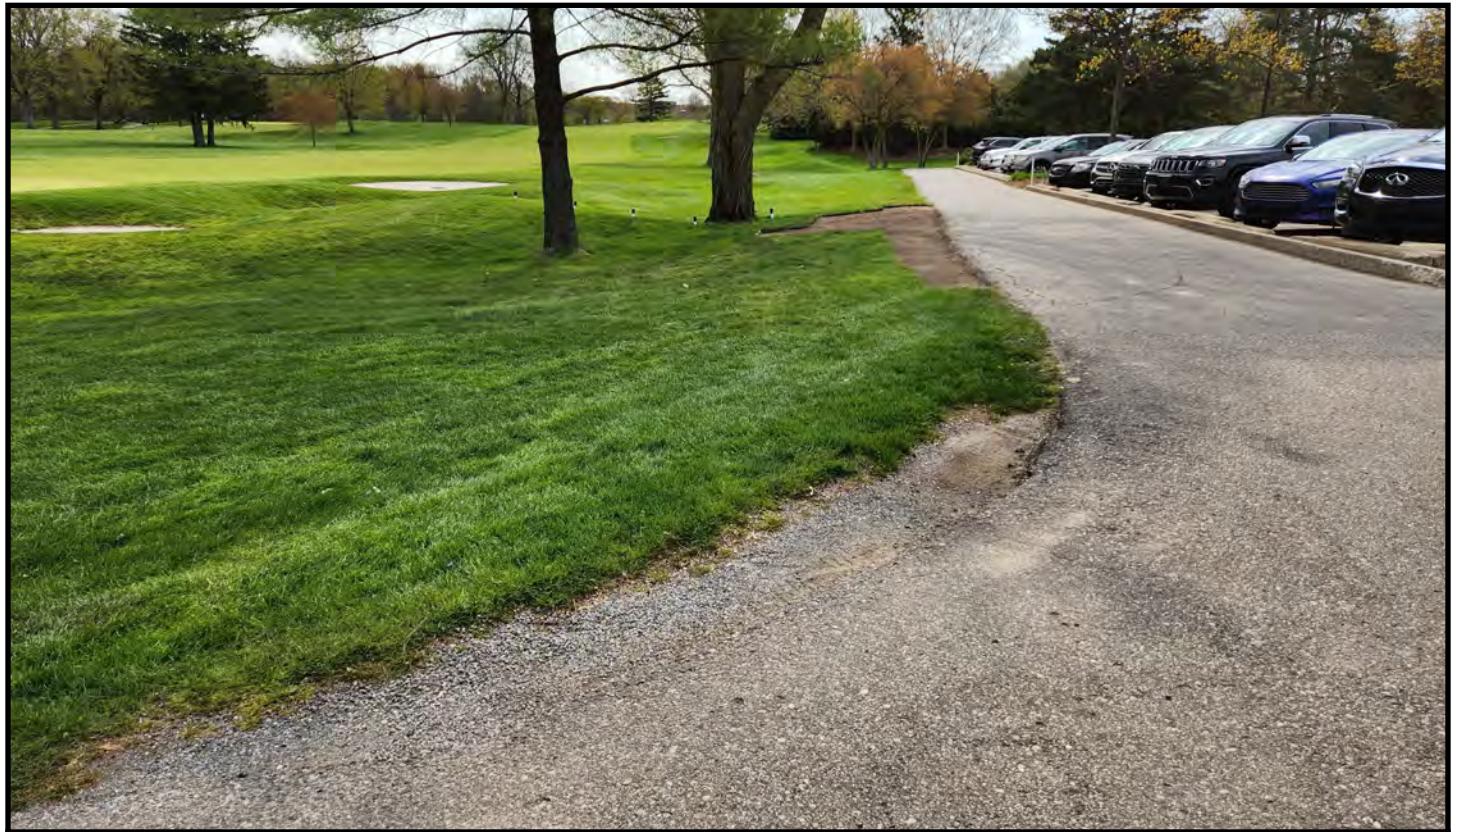
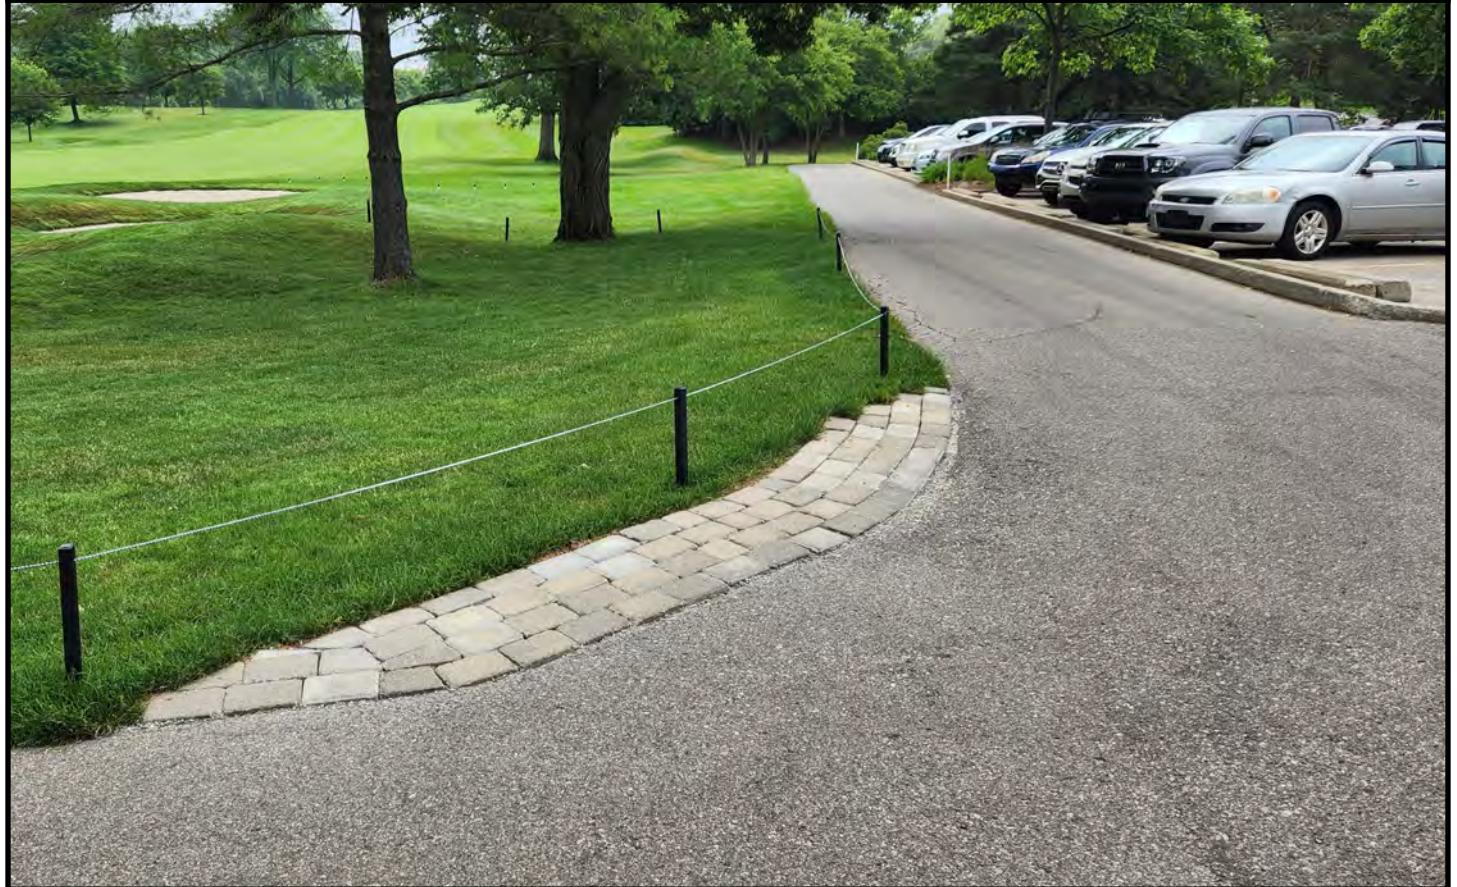
Pavers and sod installed to the left side of #9 green.

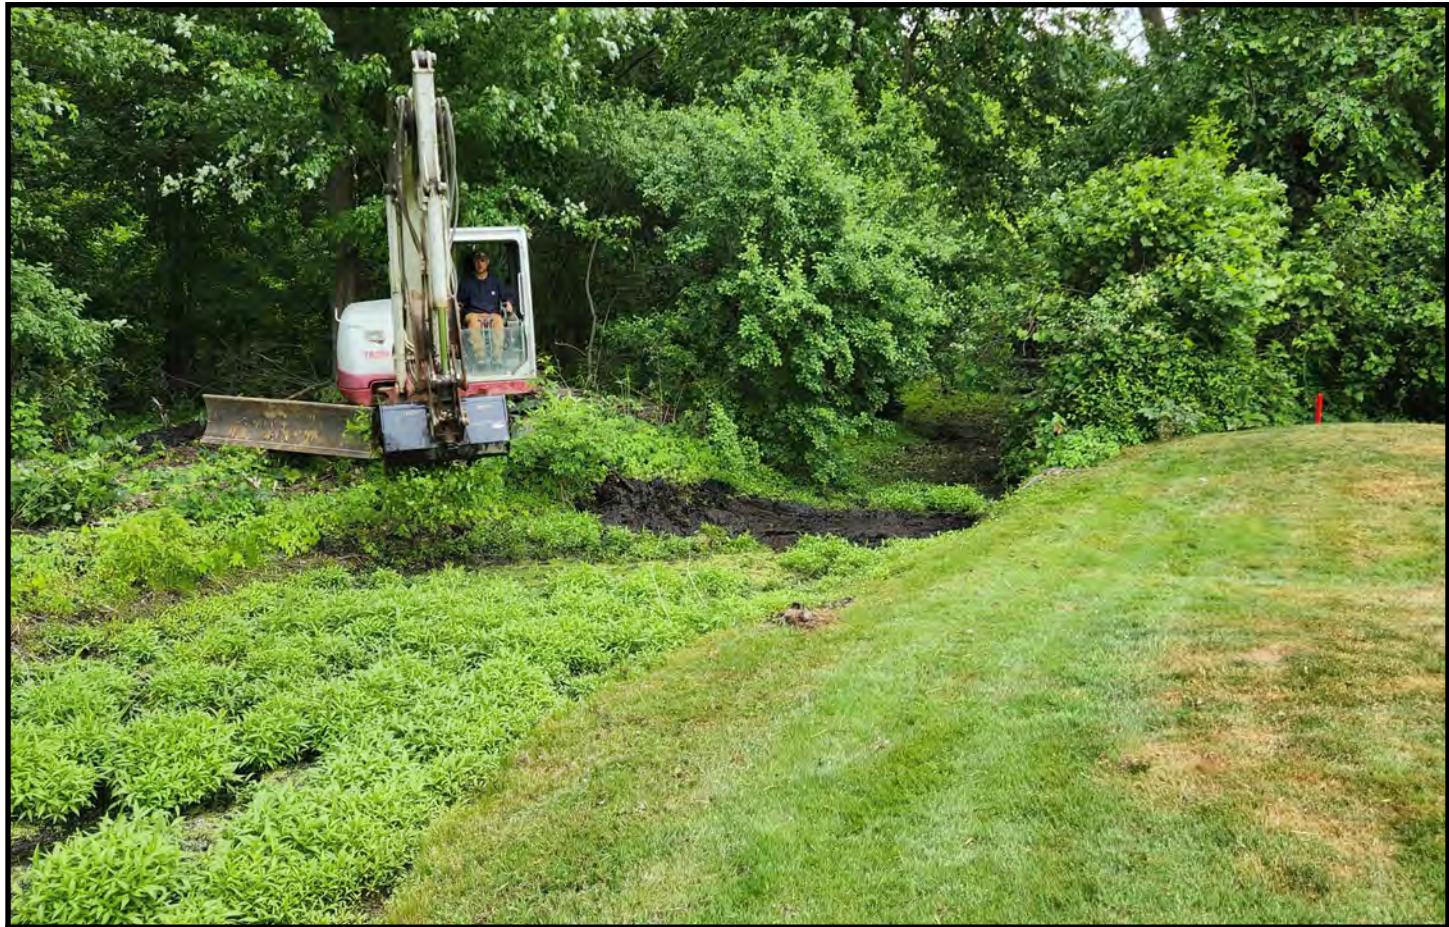
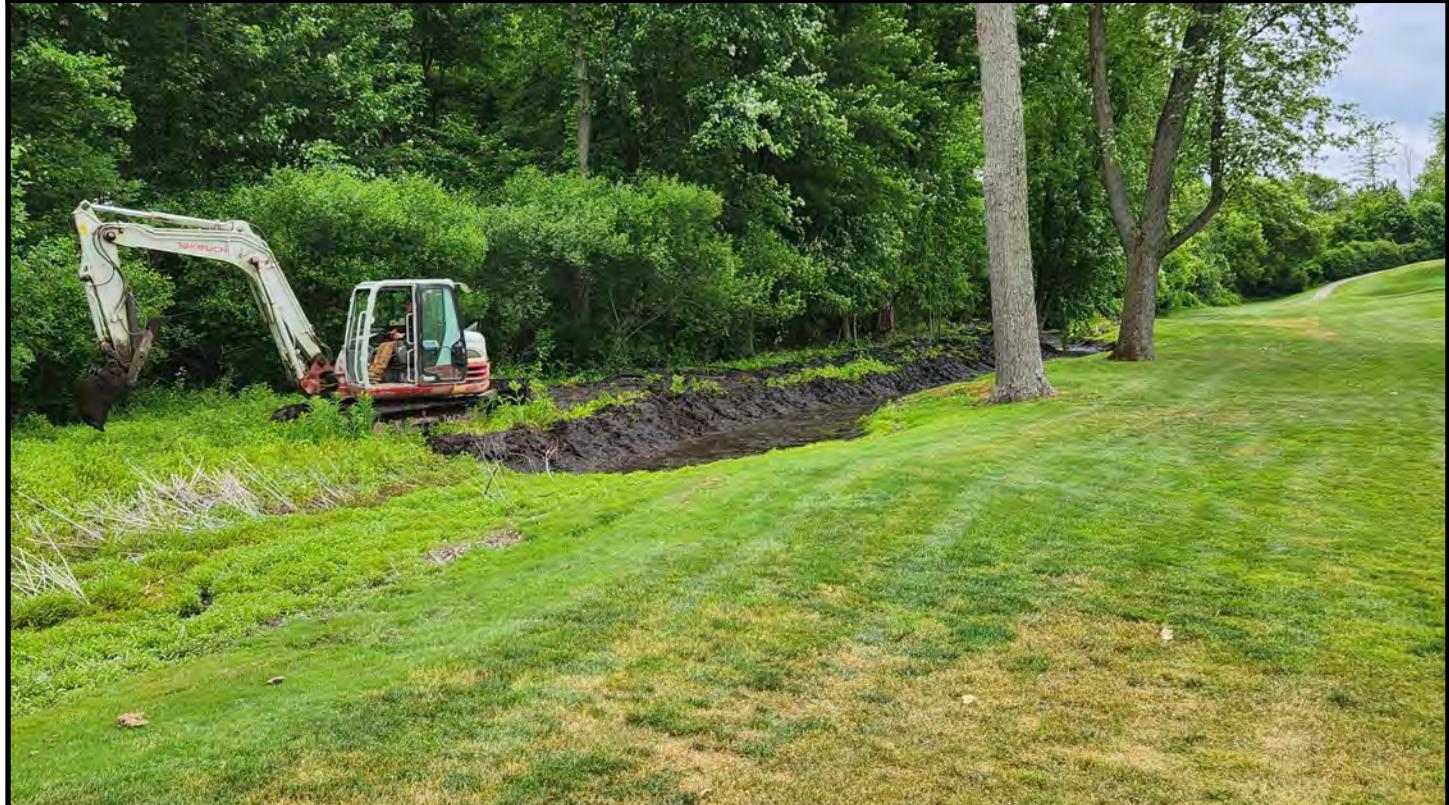
Excavator dredging the ditch left of #8. We are happy with the increased volume of water this ditch can hold after rain events.
