# grounds newsletter

We are about halfway through the 2023 golf season. I hope everyone has been enjoying the summer and hitting it straight! Mother Nature has taken us from one extreme to the other in terms of precipitation. Between April 5 - June 24 we were approximately 7.75" of rain below average. There had been 2.25" of rain, within that timeframe. From June 24 - July 17 we have received 7.1". Based on those totals, if I had to bet, I'd say we are going to have another period of dry weather sometime in the near future.

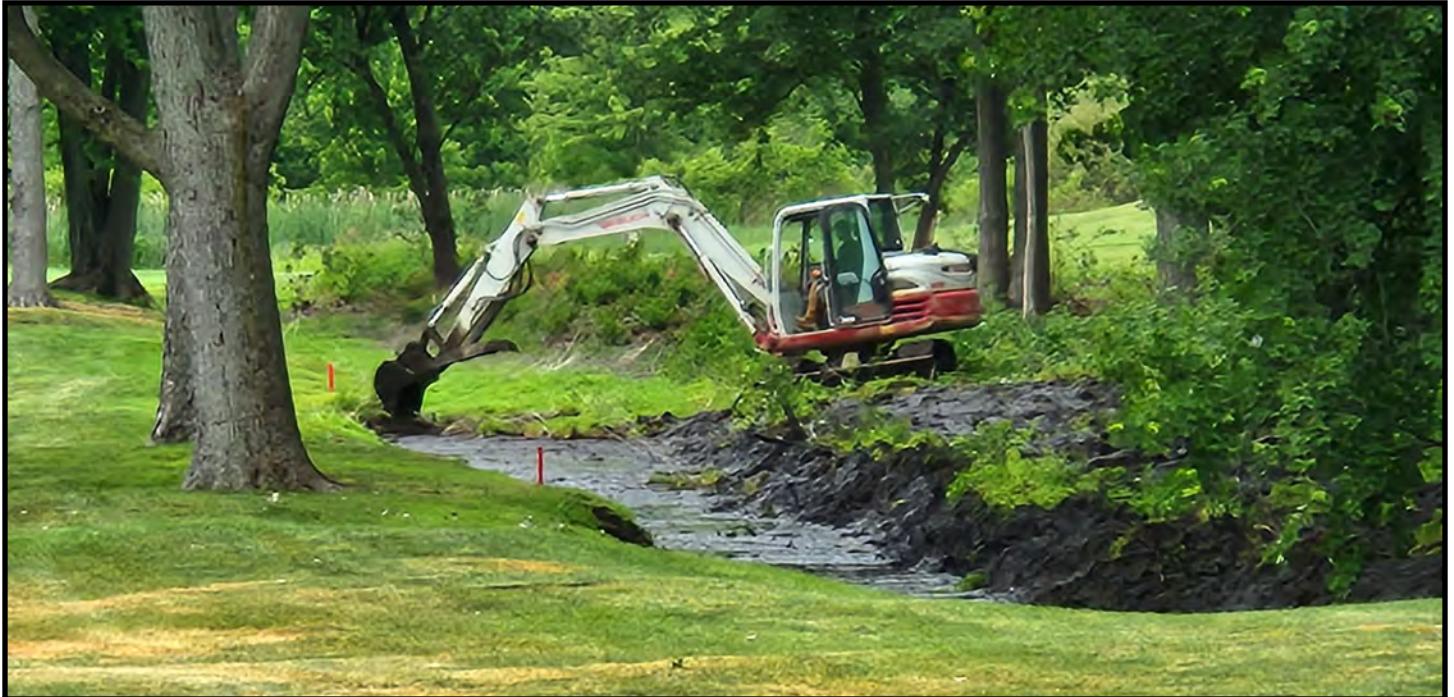
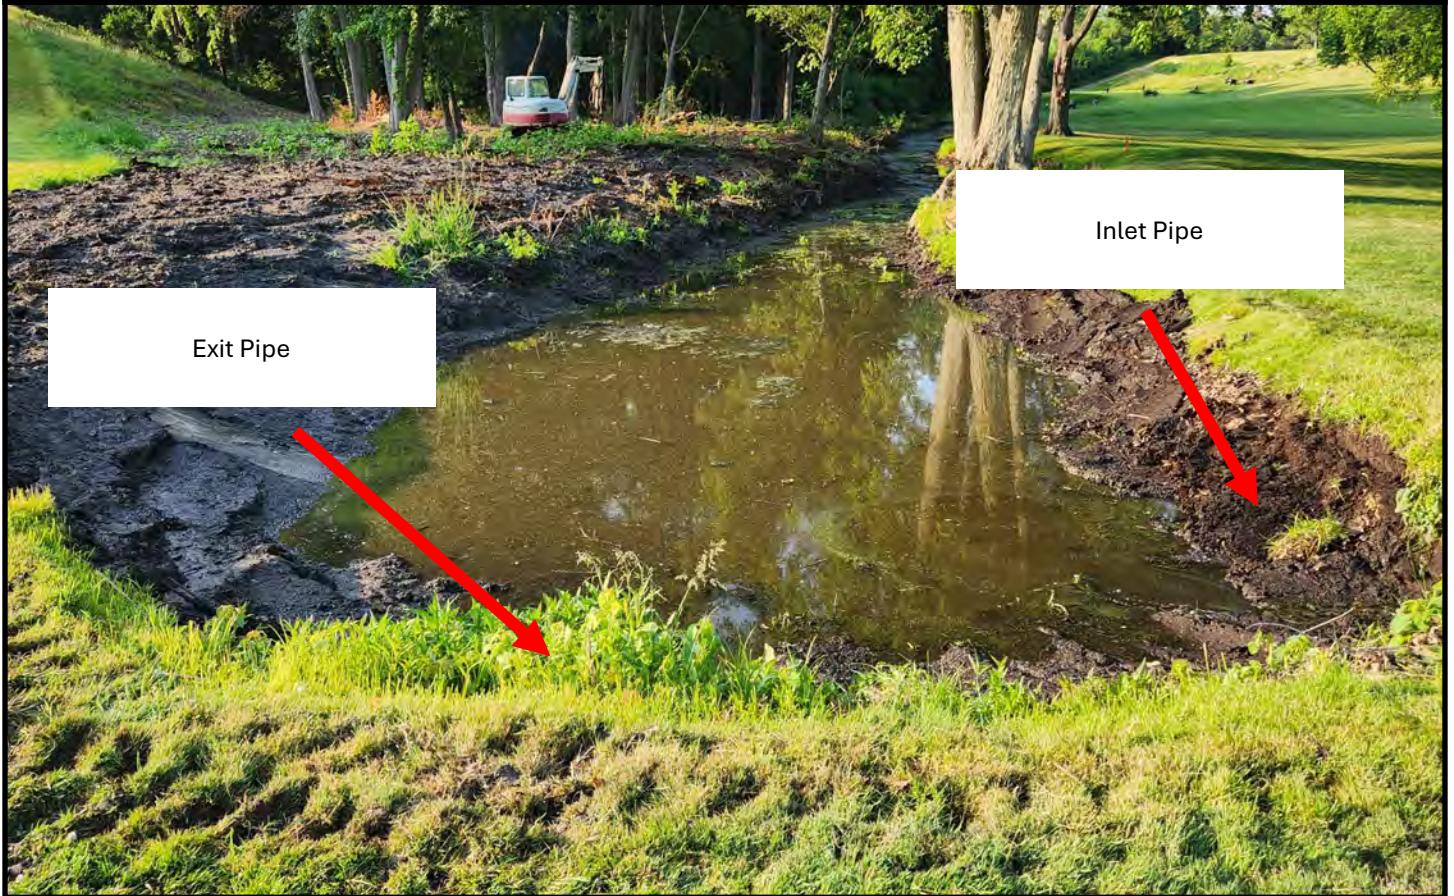
The bottom photo is the collection area where water from the clubhouse, #1, 2, 3, 8, and 9 enters through a pipe. The water then exits through a different pipe into the marsh right side of #7

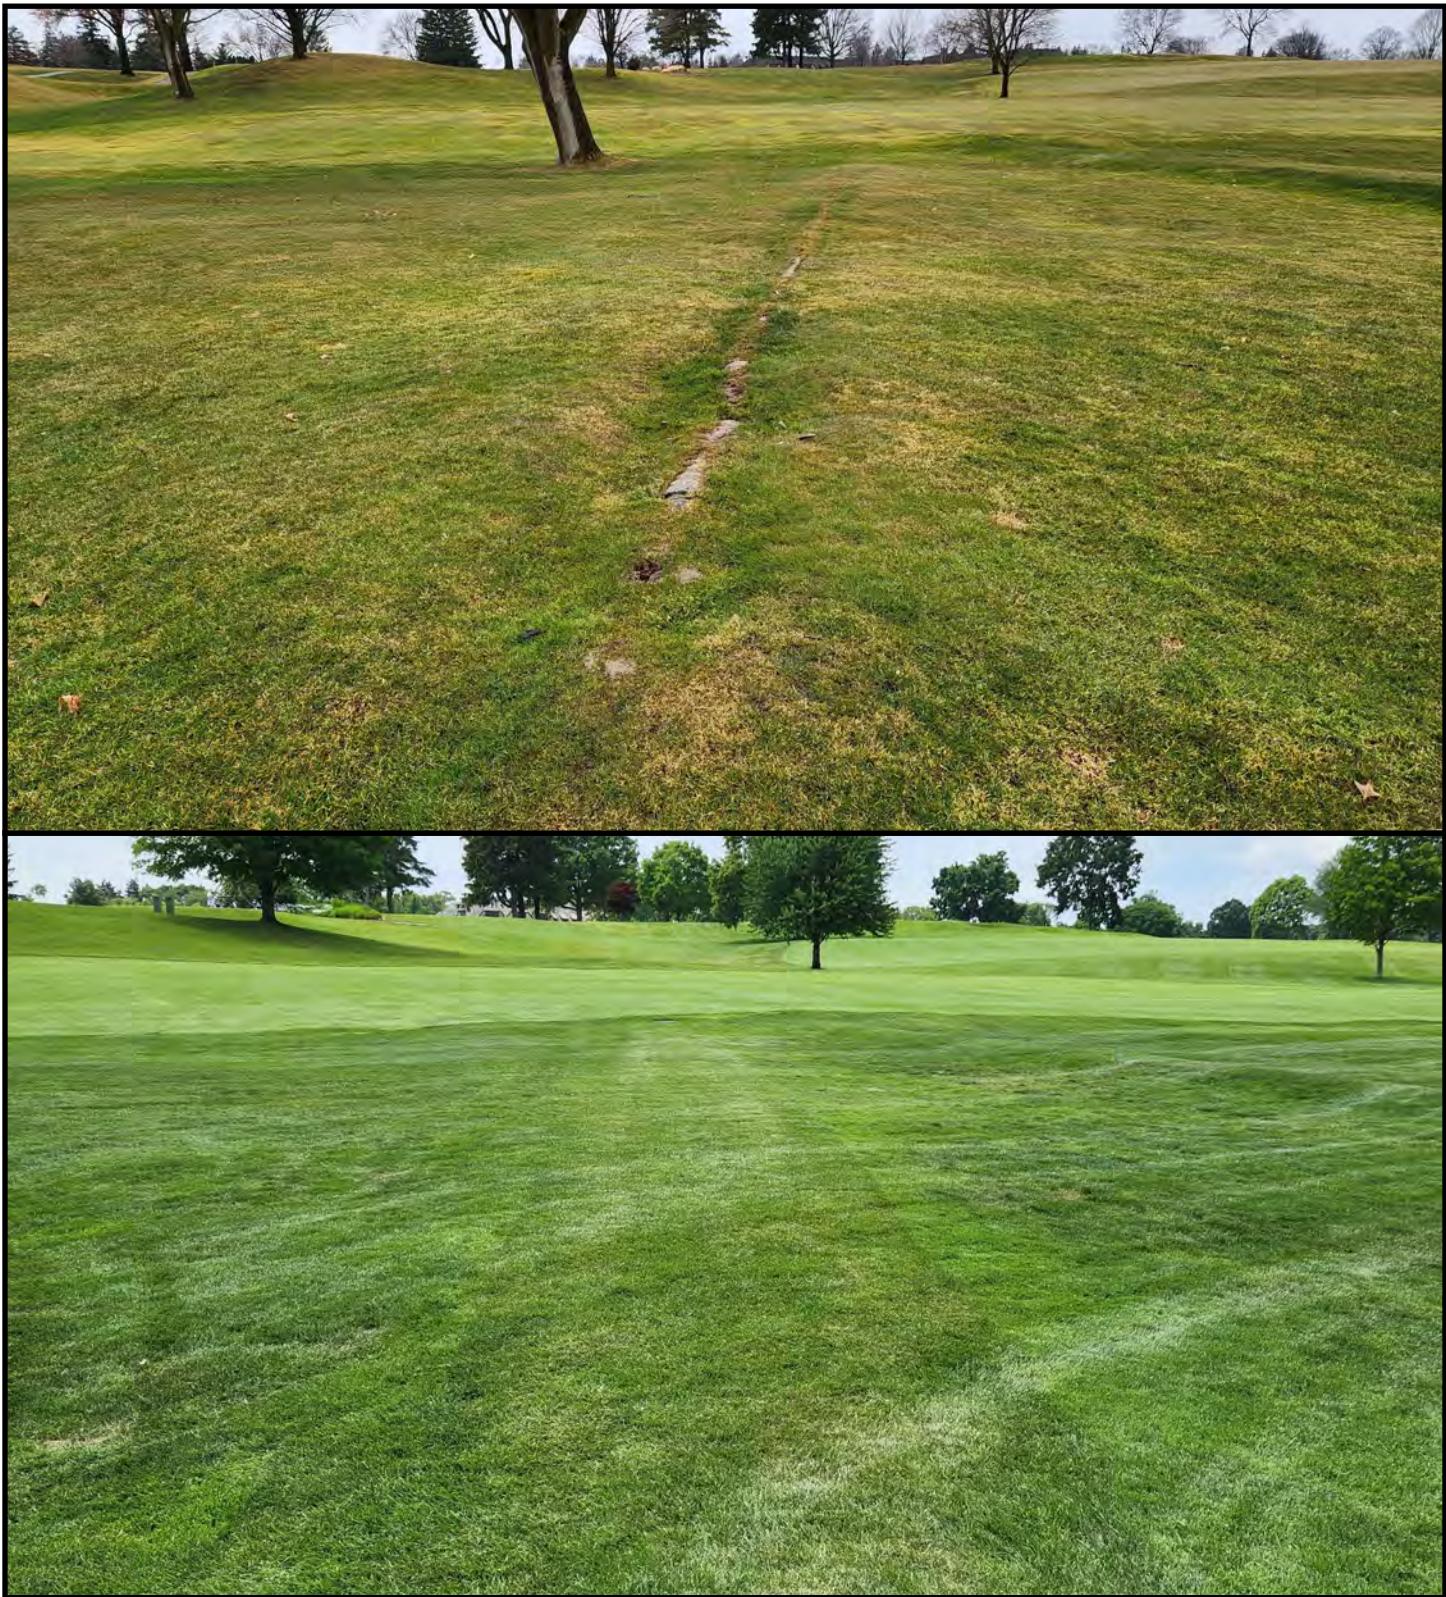
We removed and replaced the drain pipe left of #8 fairway. The old pipe was exposed on the surface and separating due to years of freeze thaw cycles. This is the same inlet pipe from the previous page draining the clubhouse, #1, 2, 3, 8, and 9.

The top photo is before and the bottom after we completed the project.

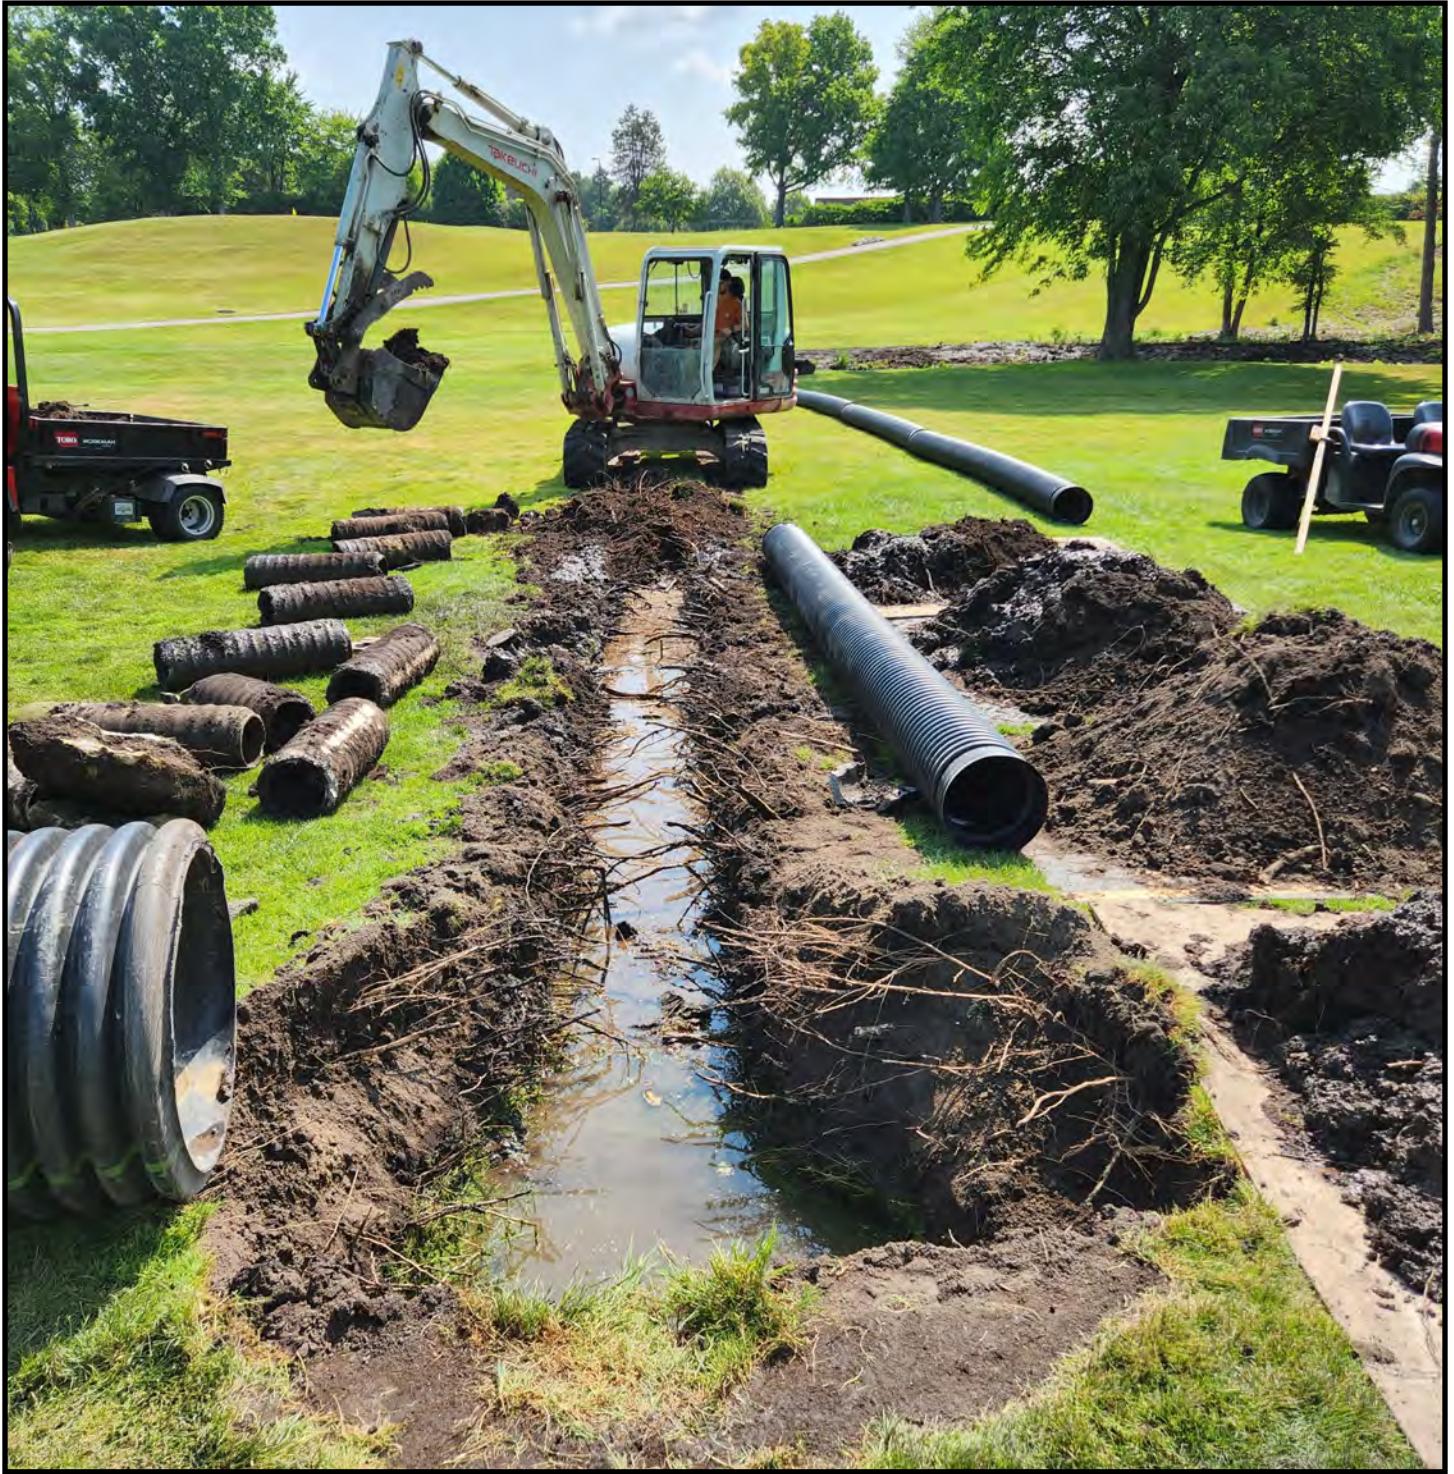
The excavator installing the new corrugated pipe to the right of the photo. The old concrete pipe is in sections on the left side of the photo. The new pipe is 2" bigger in diameter which will allow for slightly more water flow through this portion of the system.

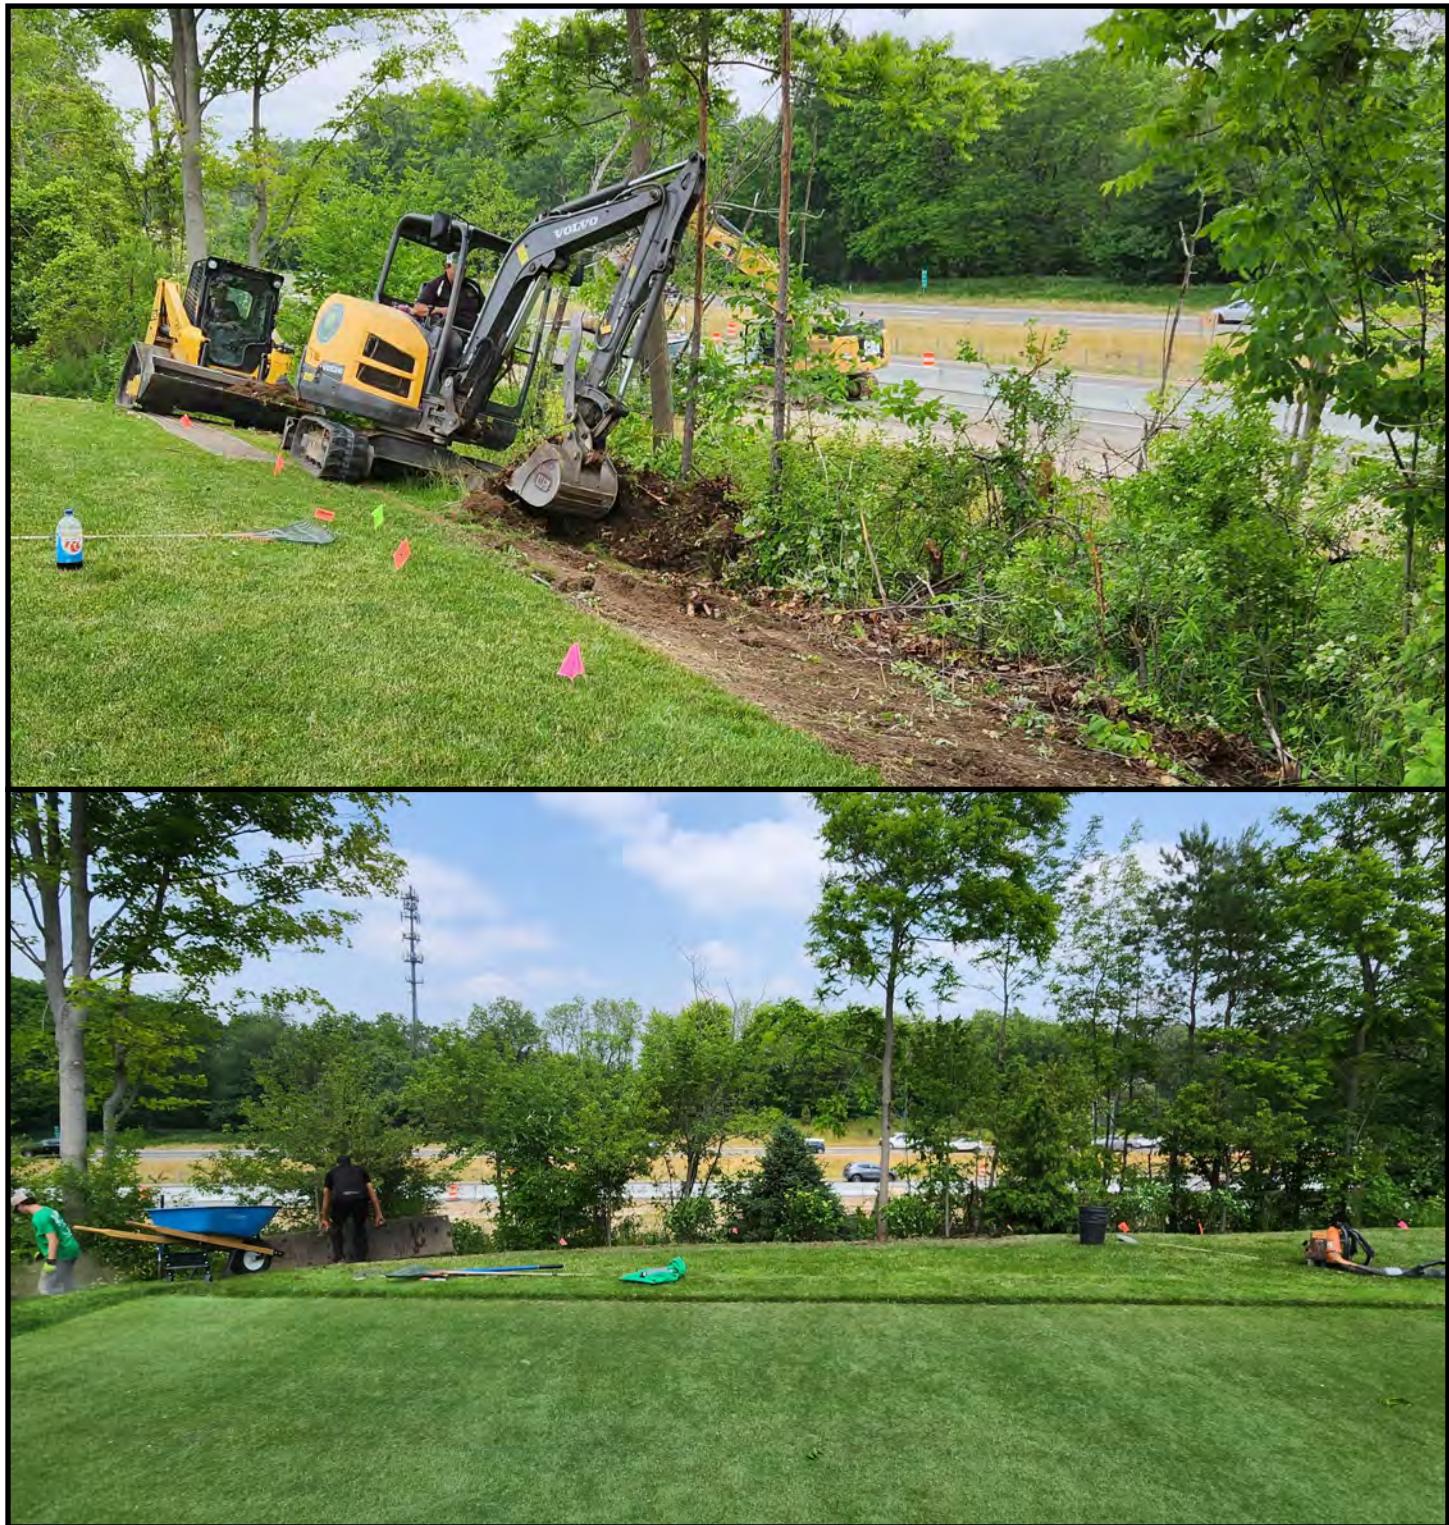
## Planting Trees Next to I96

The road commission removed several trees between our property and I96 to build a new on ramp. After the trees were removed we were left with an open view to the highway. We installed plants on our side of the property to screen this view.

The intent with the selection of plant material and design was to blend into the surrounding landscape.
